Confidential Inspection Report

LOCATED AT:
Anywhere St
Anywhere, New Hampshire 00000

INSPECTED ON:
Sunday, January 1, 2017

Inspector, Kurtis J Grasset
Norway Hill Home Inspections

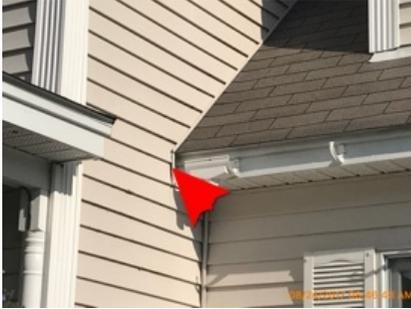
MNT No kick out flashing was observed where the roof line meets the siding. Kick out flashing will prevent roof runoff from from running down the siding and causing early deterioration. Most siding installations require Kick out flashing to meet manufacturers specification. A qualified person should install the proper kick out flashing.

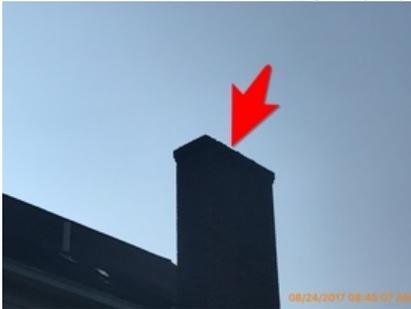
CHIMNEY AT ROOF

There is no spark arrestor or rain cap above the flue to prevent the escape of hot embers or rain entry. We recommend that a chimney cap/spark arrestor be installed, in accordance with present standards.

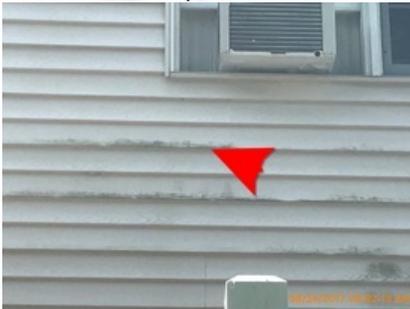
MNT Moss was present on sections of the siding. We would recommend removing.

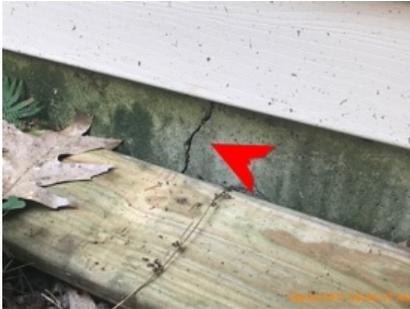
AOC **CONCRETE/BLOCK:** There are small and/or moderate cracks visible. We observed no related conditions suggesting the need for immediate repairs. We recommend these cracks be monitored. If ongoing movement is observed, further review would then be recommended.

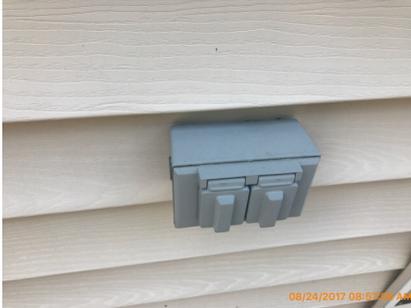
UPG GFCI protection was not found where this feature is now required. We recommend GFCI protection be installed.

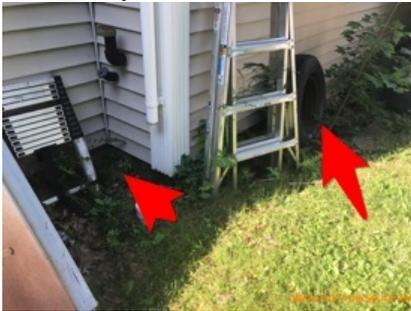
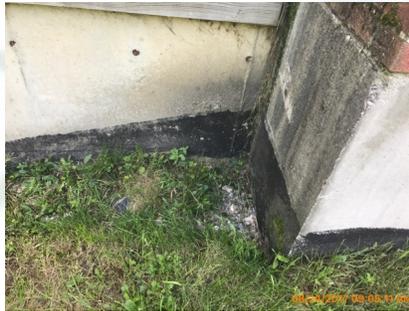
GRADING

AOC Grading is sloped toward the structure in some areas. Low spots and negative grading promote water accumulation near the building, leading to foundation problems. Regrading would help ensure that surface water flows away from the structure.

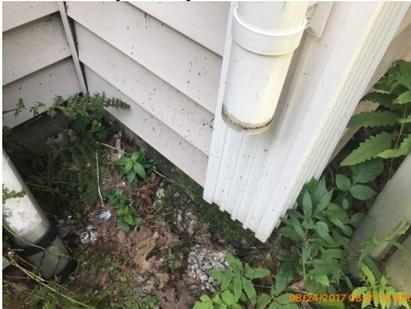
DOWNSPOUTS

MNT Runoff water from the roof discharges next to the house. We recommend the downspouts be routed sufficiently away from the structure to prevent puddling, pooling, and saturation of the soil around the building.

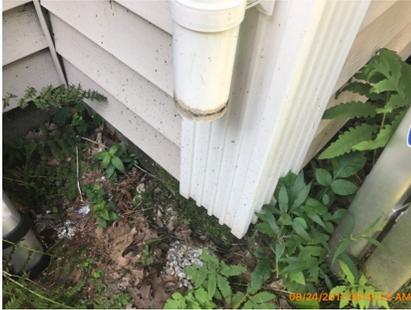
MNT Splash blocks, directing water away from the foundation, were not at the base of every downspout. We recommend that a splash block be installed for every downspout.

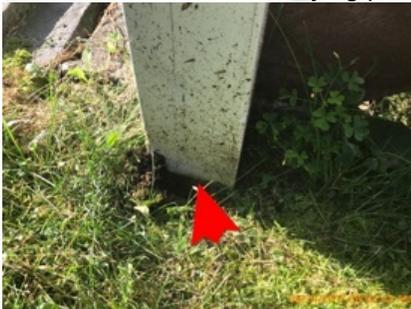
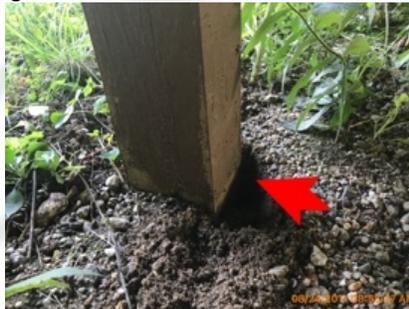
AOC There is earth-to-wood contact at the bottoms of some deck support posts. This condition is conducive to infestation of wood-destroying pests/organisms. We are unable to determine the depth or presence of a footing

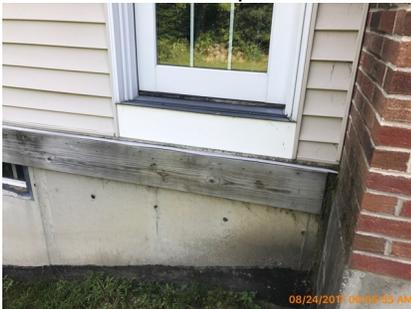
STAIRS

UPG No stairs were present at the left. We would recommend installation.

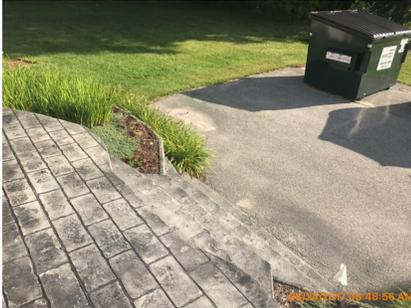
RAILINGS

UPG There are no railings where needed in several areas. As a safety measure, we recommend that railings be installed.

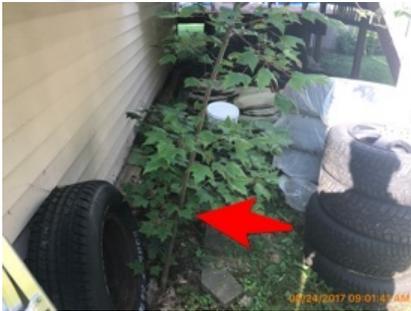
VEGETATION

MNT A small tree is touching the structure at the rear. We consider this a potential threat to the structure. To eliminate the potential for damage, we recommend modification of the structure to accommodate the tree or removal of the tree.

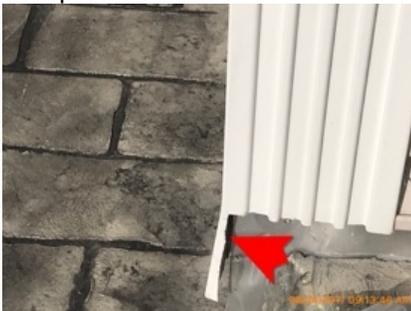
TRIM

MNT The trim is loose or improperly secured at the right. We recommend it be resecured in accordance with accepted standards.

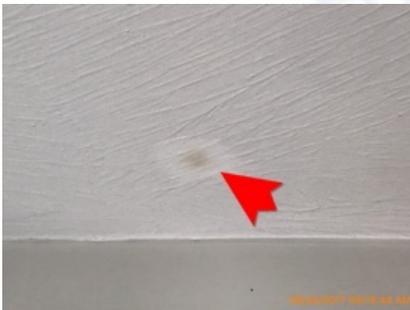
We noted stains on the ceiling but were unable to identify their source. We recommend inquiries of the owner and/ or occupant, who may have further knowledge regarding their source and whether corrective repairs have been made.

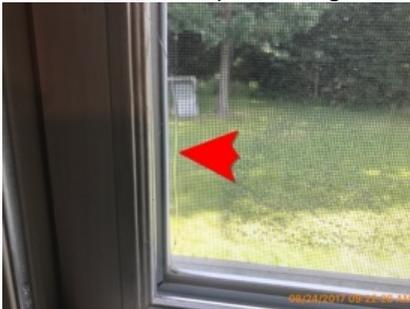
MNT One or more panes of glass are broken. We recommend all broken glass be replaced.

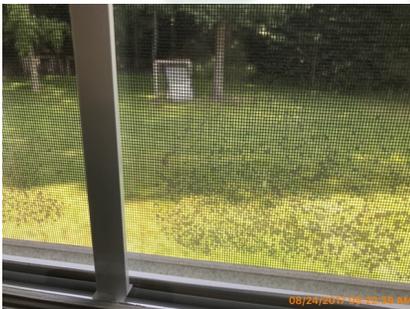
MNT There is condensation between the panes of glass of several double pane windows. This indicates a failed seal. We recommend the lens assemblies be replaced, which is the only method for correcting this deficiency.

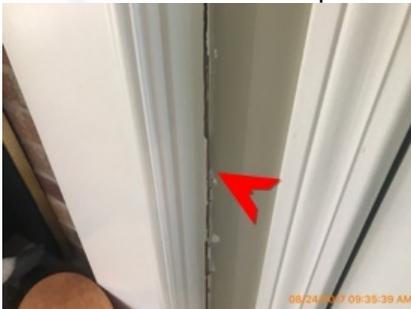
Trim was loose around fireplace. We would recommend repair or replacement.

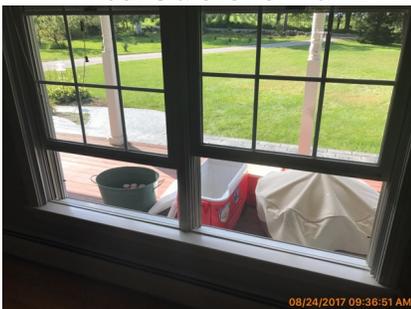
WINDOWS

AOC Windows are lower than 24 inches at the front. We would recommend installing guards.

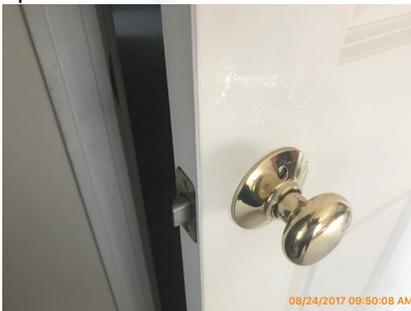
MNT SWINGING: The entry door rubs on the frame. We recommend it be planed or sanded for smoother operation.

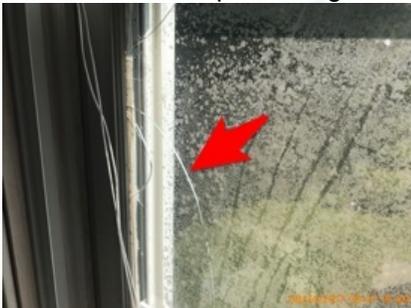
MNT One or more panes of glass are broken. We recommend all broken glass be replaced.

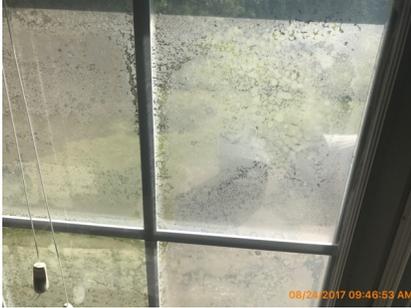
MNT There is condensation between the panes of glass of one double pane window. This indicates a failed seal. We recommend the lens assembly be replaced, which is the only method for correcting this deficiency.

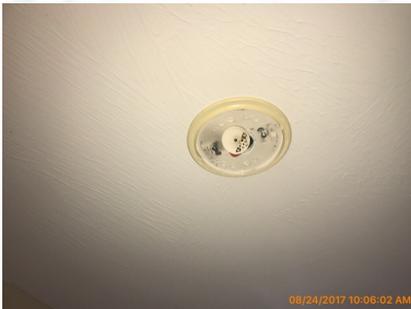
MNT The smoke detector is defective and should be replaced.

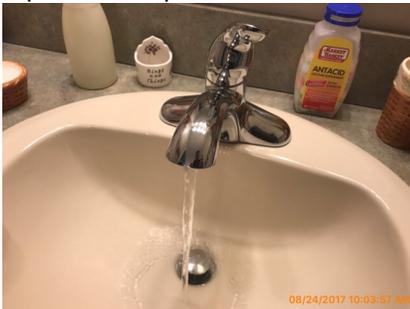
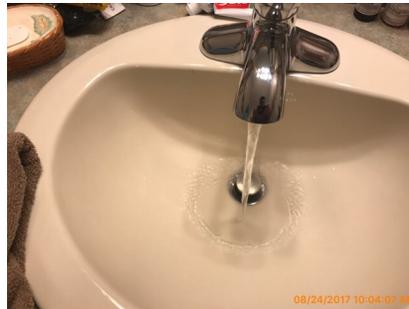
MNT The drain stop is defective, an adjustment is needed in order for the sink to hold water. We recommend it be repaired or replaced.

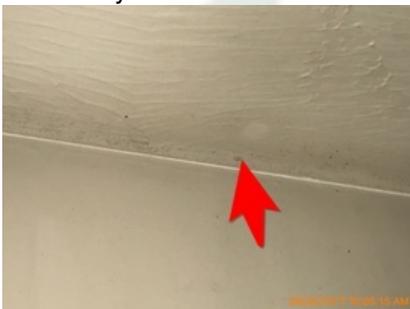
MNT Mold and mildew have built up on the exposed shower walls. These surfaces should be cleaned and chemically treated to eliminate this growth and minimize recurrence.

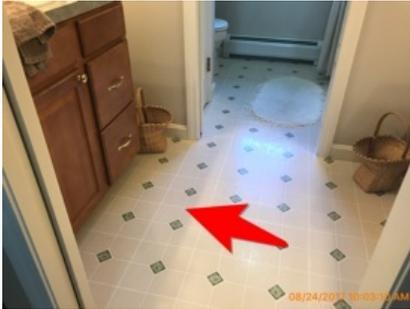
Minor slope in bathroom floor was present. There was no obvious indications of the exact cause. No Visible defects were noted.

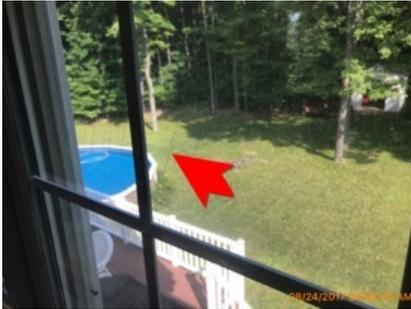
UPG There is condensation between the panes of glass of several double pane windows. This indicates a failed seal. We recommend the lens assemblies be replaced, which is the only method for correcting this deficiency.

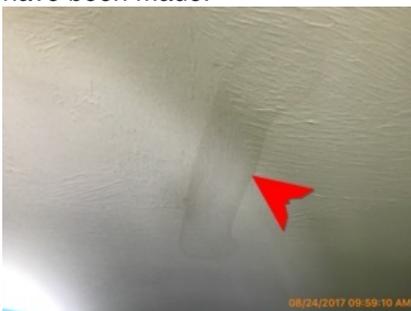
We noted water stains on the ceiling but were unable to identify their source. We recommend inquiries of the owner and/or occupant, who may have further knowledge regarding their source and whether corrective repairs have been made.

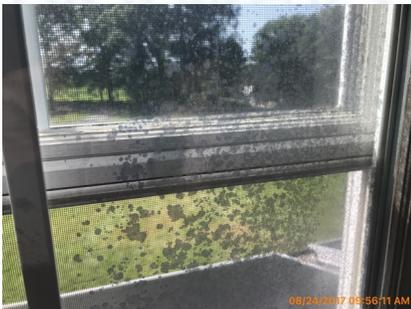
UPG There is condensation between the panes of glass of several double pane windows. This indicates a failed seal. We recommend the lens assemblies be replaced, which is the only method for correcting this deficiency.

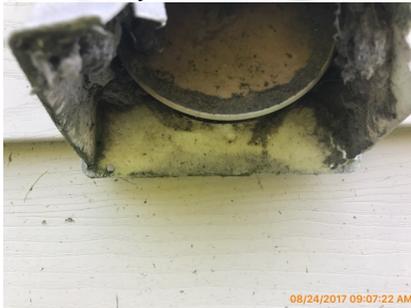
The dryer vent has accumulated dirt and debris. We recommend it be cleaned.

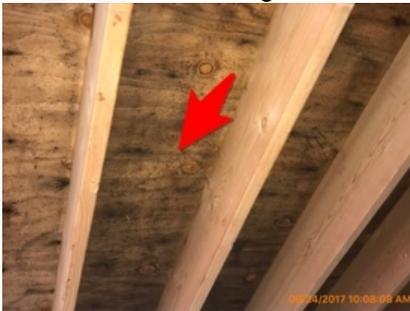
AOC Discoloration was noted on the sheathing. This is most likely a condition caused by a lack of ventilation. We recommend increasing the ventilation.

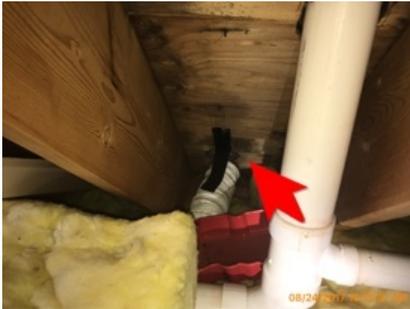
AOC The duct from the upstairs bathroom exhaust fan does not go to the exterior. This condition allows excessive moisture to be vented into the attic. We recommend this deficiency be corrected.

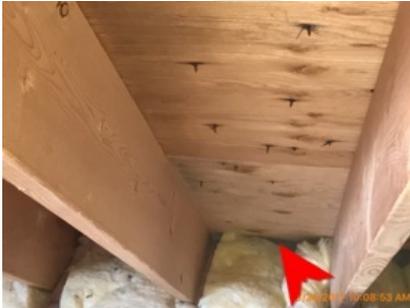
AOC Vents in the attic are blocked, reducing circulation. We recommend they be cleared.

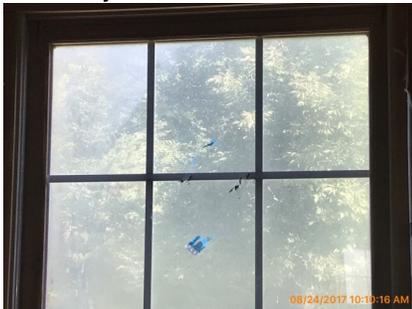
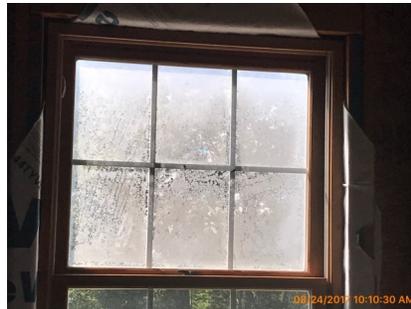
UPG Windows have lost thermal seal, we would recommend repair or replacement to have optimal energy efficiency.

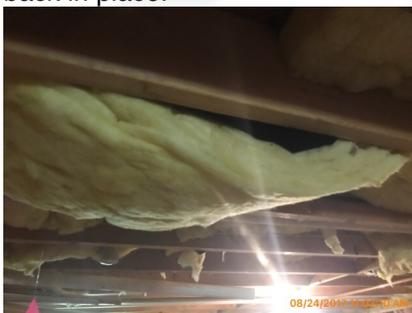
MNT There are fiberglass batts in the basement have fallen out of place. We recommend this material be secured back in place.

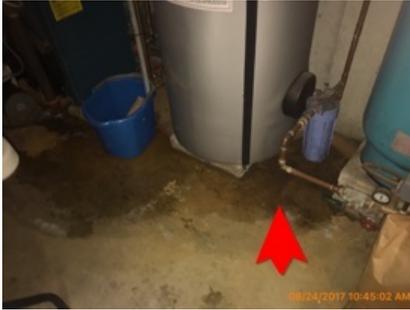
There was a puddle of water near the boiler and pressure tank is. We are unable to determine cause. We recommend consulting owner for potential causes.

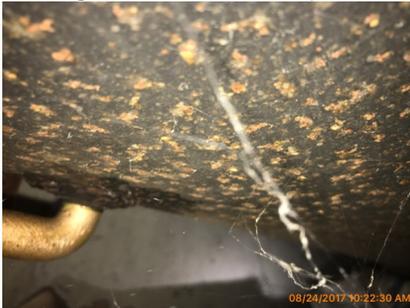
OIL TANK AND PIPING

Some surface rust was observed on the bottom of the oil tank. No weeping or drips were observed. A proper coating of rust resistance paint may help to prolong the life of the tank

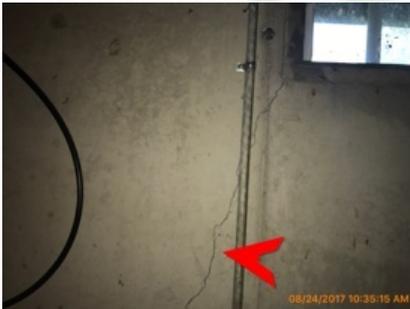
MNT CONCRETE/BLOCK: There are small and/or moderate cracks visible. We observed no related conditions suggesting the need for immediate repairs. We recommend these cracks be monitored. If ongoing movement is observed, further review would then be recommended.

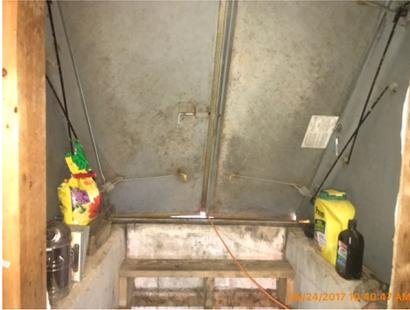
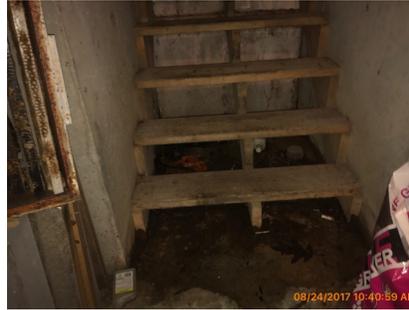
AOC **CONCRETE/BLOCK:** This bulkhead does not appear to be water tight. Repairs are needed to prevent further deterioration and damage.

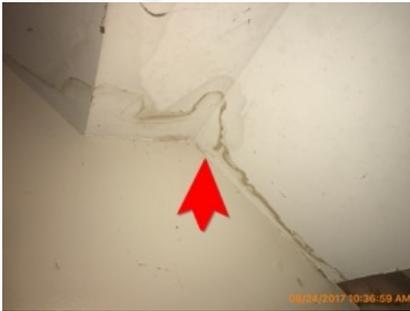
MNT There are stains from leakage on the basement walls. This appears to be a minor condition that may be an annoyance but, in our opinion, is not structurally significant. We recommend monitoring during periods of heavy rain.

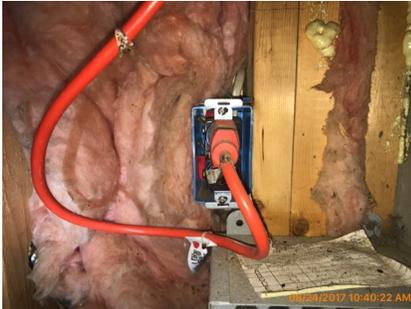
MNT COVER PLATES: One of the receptacles is missing its cover plate. We recommend it be replaced to reduce the risk of electrical shorts and hazardous shocks.

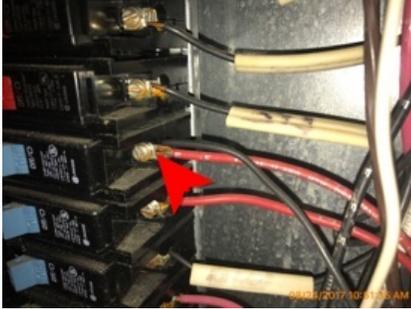
AOC **PANEL:** At least one double tap was observed in the breaker panel. A double tap occurs when one fastener is used to connect 2 wires. One fastener will not secure both wires equally and may lead to heat buildup. Consultation with a qualified electrician will help determine if these need to be repaired.

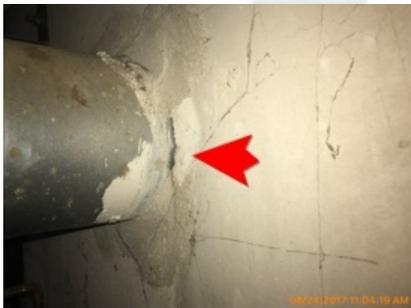
MNT The heating system vent connector is poorly connected at the opening into the brick chimney. We recommend the connection be made secure and air tight.
