Confidential Inspection Report

INSPECTED ON:
Tuesday, April 29, 2025

Norway Hill Home Inspections

Septic System

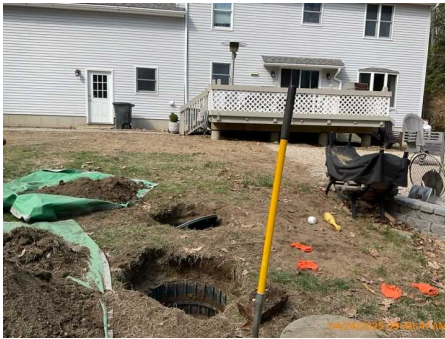
6: Tank type was concrete.

7: Tank location was in the rear of the building.

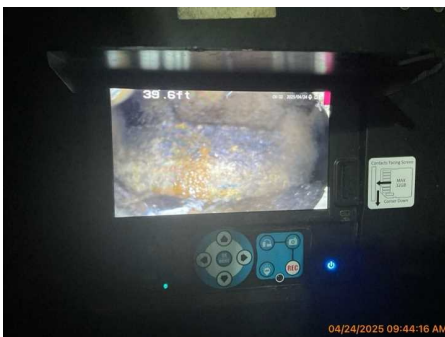
Inlet Baffle

12: The inlet baffle was intact and was in serviceable condition.

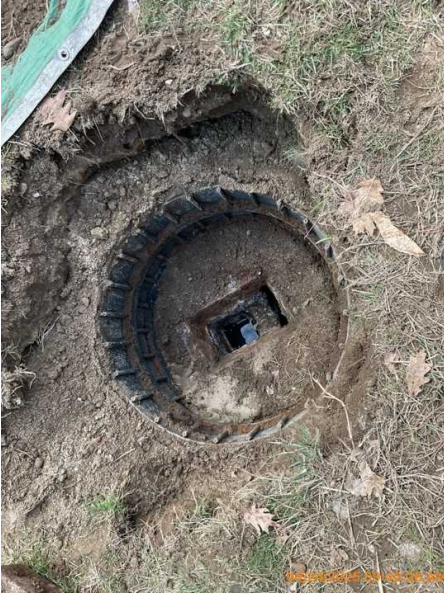
Outlet Baffle

13: The outlet baffle was inspected and in serviceable condition.

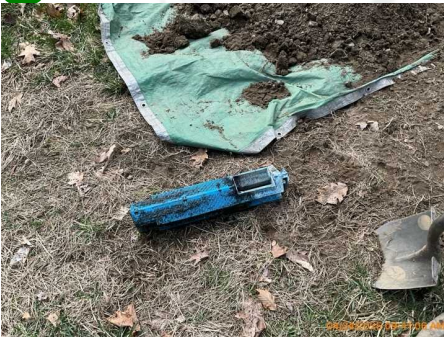
Filter

MNT 14: The outlet filter was dirty before the inspection, and during the inspection, we cleaned the filter.

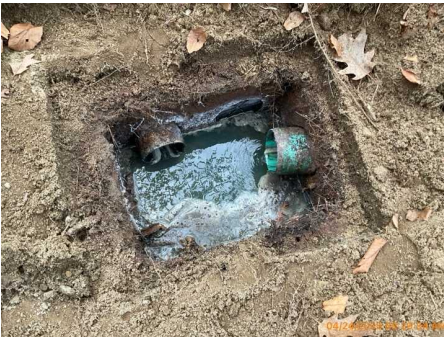
Distribution Box

16: The D box was located and appears to be in serviceable condition for its age.

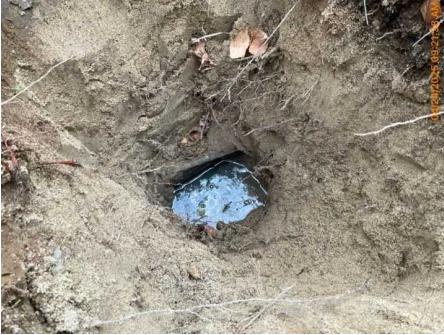
Septic field General

AOC 18: The leaching system was holding effluent. This was an indication that the leaching system was at or near the end of its life. Consultation with a licensed designer will help provide options for extending its useful life or replacing the system if required.

AOC s-18: The leaching system was holding effluent. This was an indication that the leaching system was at or near the end of its life. Consultation with a licensed designer will help provide options for extending its useful life or replacing the system if required.

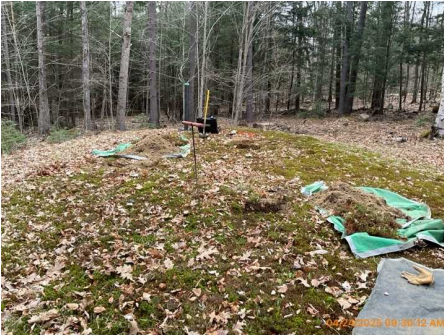
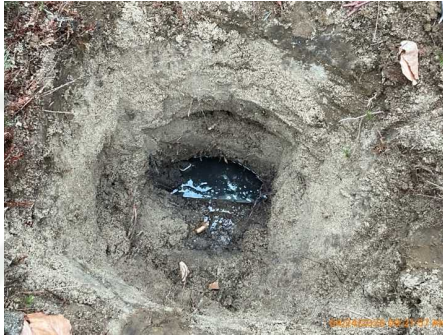
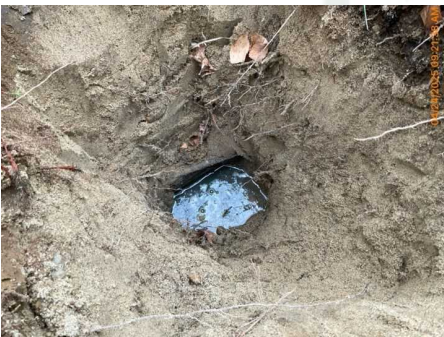
Septic field Eljen

AOC 19: FIELD CONDITION: POOR : The field was comprised of a Eljen system. There was staining and or standing effluent within the sand around the leaching system. This is an indication of advanced aging. We would recommend a consultation with a licensed septic designer.

AOC s-19: FIELD CONDITION: POOR : The field was comprised of a Eljen system. There was staining and or standing effluent within the sand around the leaching system. This is an indication of advanced aging. We would recommend a consultation with a licensed septic designer.
