Confidential Inspection Report

LOCATED AT:
Anywhere St
Anywhere, New Hampshire 00000

INSPECTED ON:
Sunday, January 1, 2017

Inspector, Kurtis J Grasset
Norway Hill Home Inspections

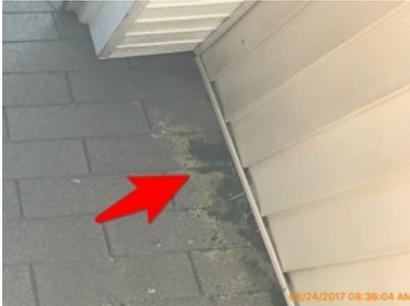
MNT Moss was observed on the roof covering. Aggressive methods to remove moss may result in increased damage to the roof surface. We recommend less aggressive methods, such as sprays or the use of copper flashing. These areas of the roof covering will need to be monitored as they may be the first area to deteriorate.

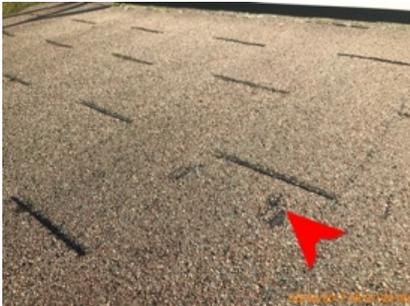
AOC The shingles are damaged and deteriorated in some areas. Further evaluation by a qualified roofing contractor is needed to determine the exact cause and appropriate repair.

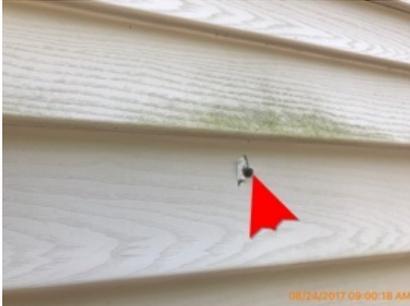
MNT Sections of the vinyl siding are punctured. We recommend these sections be repaired or replaced.

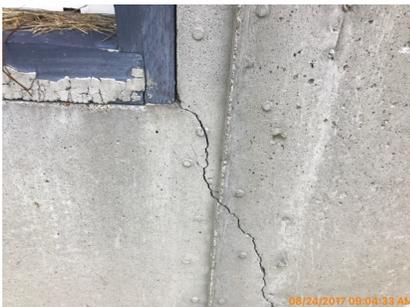
MNT CONCRETE/BLOCK: Hairline and/or small cracks, within normal tolerances, are visible. This type of cracking is often a result of shrinkage of materials and/or minor settlement and usually does not affect the strength of the foundation. No action is indicated.

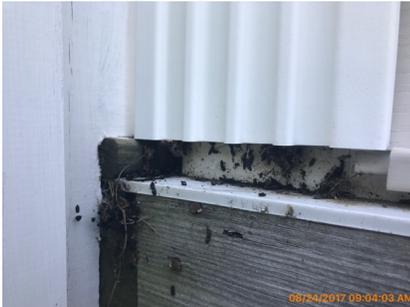
Rodents have been active. It is possible there is no current infestation. We recommend that bait or traps be set and monitored. The advice and services of a licensed exterminator would be recommended if problems persist.

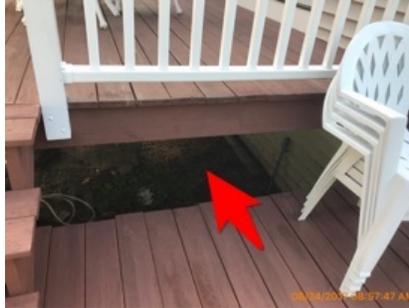
UPG There are no railings where needed in several areas. As a safety measure, we recommend that railings be installed.

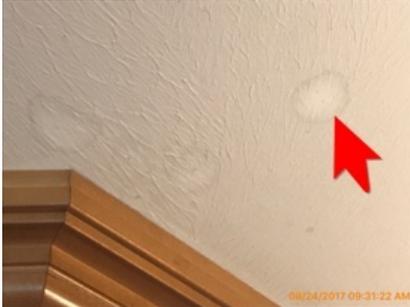
We noted water stains on the ceiling but were unable to identify their source. We recommend inquiries of the owner and/or occupant, who may have further knowledge regarding their source and whether corrective repairs have been made.

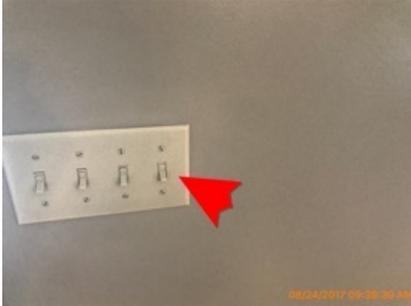
MNT GENERAL: There are switches for which no purpose was immediately obvious. We recommend inquiries of the owner to determine what is controlled by these switches.

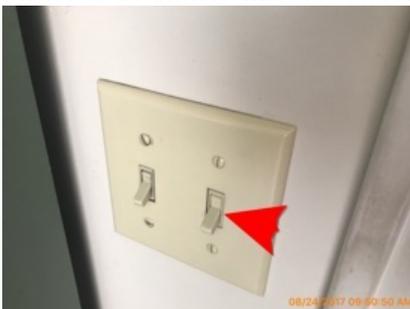
GENERAL: There are switches for which no purpose was immediately obvious. We recommend inquiries of the owner to determine what is controlled by these switches.

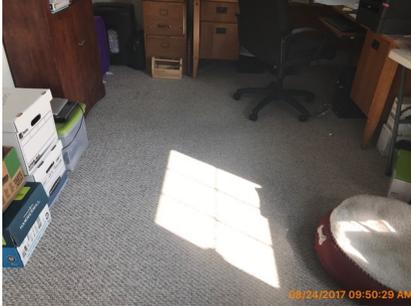
MNT GENERAL: The floor squeaks when walked on. This does not affect the functional use of the floor. Squeaks can usually be eliminated, if desired, by additional attachment of the subfloor to the floor joists.

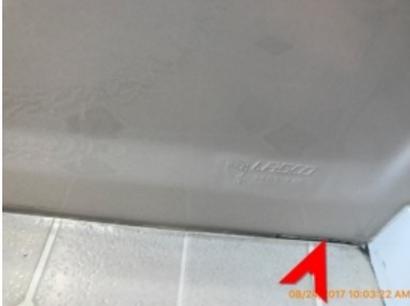
MNT The floor edge at the base of the shower/tub is loose as a result of over-splash. The floor should be resecured and caulked to prevent moisture penetration and subsequent damage.

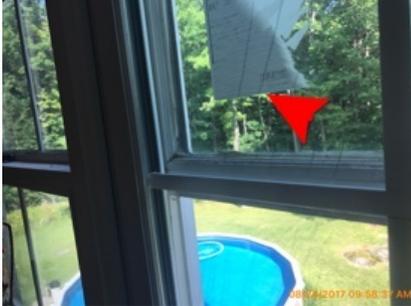
UPG There is condensation between the panes of glass of one double pane window. This indicates a failed seal. We recommend the lens assembly be replaced, which is the only method for correcting this deficiency.

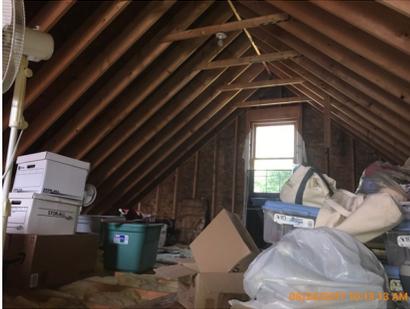
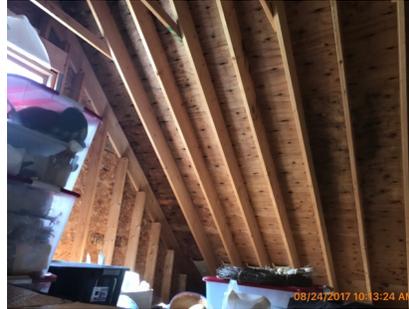
AOC The duct from the upstairs bathroom exhaust fan does not go to the exterior. This condition allows excessive moisture to be vented into the attic. We recommend this deficiency be corrected.

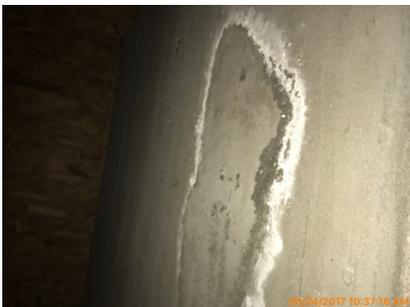
CONCRETE/BLOCK: There is a condition known as 'efflorescence' on portions of the foundation walls. This whitish, fuzzy material is a 'salt' deposit left when moisture in the foundation evaporates on the inside of the foundation.

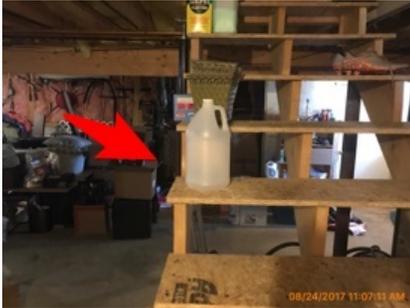
The basement stairs do not have a handrail. We strongly recommend a handrail be installed for safety.

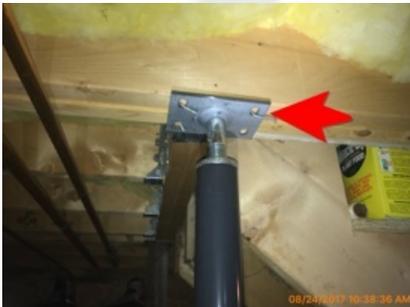
The floor system is supported by adjustable steel jacks, some engineers consider these temporary supports. If movement is noticed these should be replaced with a solid steel Lally column.

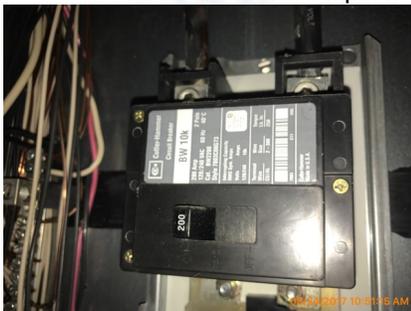
MAIN DISCONNECT

The main disconnect is incorporated into the electrical service panel.

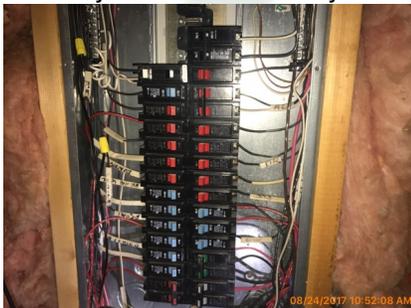
GENERAL: The main service panel is in serviceable condition with circuitry generally installed and fused correctly, with only minor items worthy of attention.

AOC **PANEL:** At least one double tap was observed in the breaker panel. A double tap occurs when one fastener is used to connect 2 wires. One fastener will not secure both wires equally and may lead to heat buildup. Consultation with a qualified electrician will help determine if these need to be repaired.

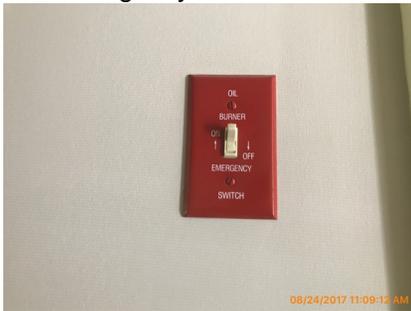
EMERGENCY SHUT OFF SWITCH

The emergency shutoff switch is located in the hallway.

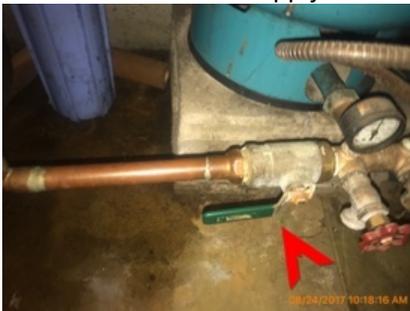
PLUMBING

The domestic water supply main shut-off valve is in the basement.

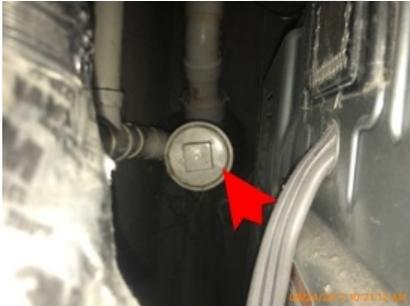
SEWER CLEANOUT

The sewer cleanout is located in the basement.

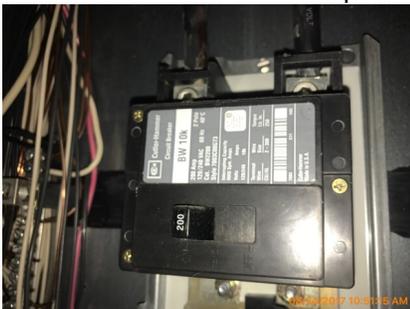
MAIN DISCONNECT

The main disconnect is incorporated into the electrical service panel.

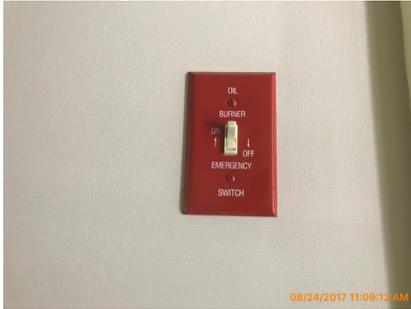
EMERGENCY SHUT OFF SWITCH

The emergency shutoff switch is located in the hallway.
